Bank upgrade relies on ashlar stonework

Using an alternating pattern of thin-cut black and Sand Beige limestone veneer, as well as granite elements, RPR Architects established a unique setting for the Alta Alliance Bank in Oakland, CA

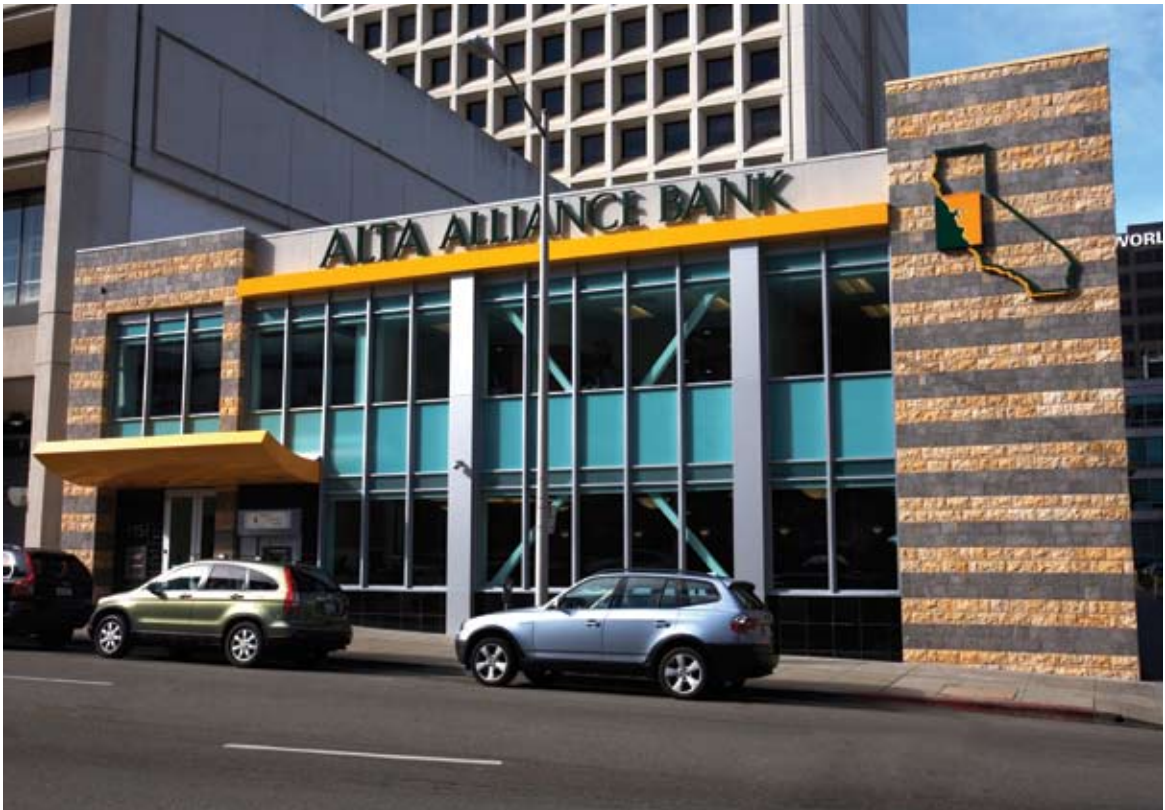
The facade of the 13,000-square-foot Alta Alliance Bank headquarters building, located in Downtown Oakland, CA, features alternating stripes of black and Sand Beige dolomitic limestone in an ashlar pattern, which was added to update the look of the exterior facade.

The exterior facade of the building features alternating stripes of black and Sand Beige dolomitic limestone — which was quarried in Indonesia — in a combination of bushhammered and split-faced finishes. The material was supplied by Im Ex Ware of Henderson, NV, and distributed by Dal-Tile Corp. of San Leandro, CA.

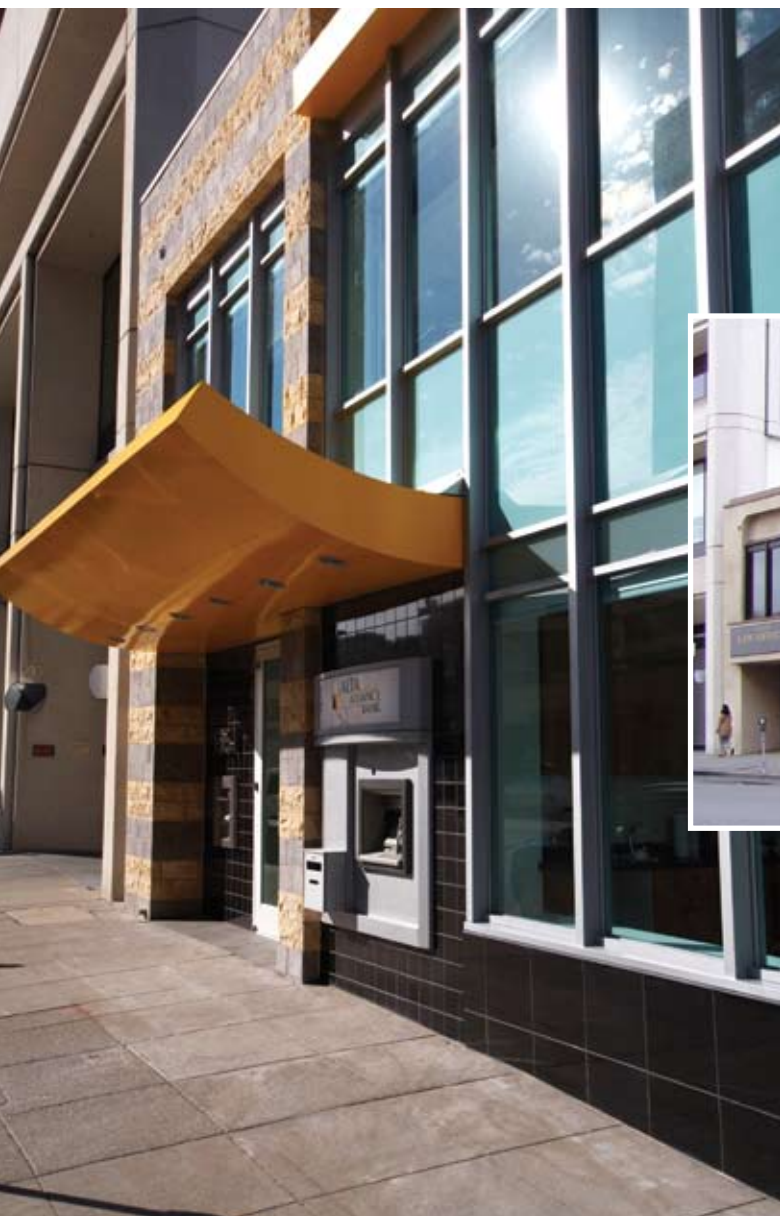
In addition to limestone, 18- x 18-inch pieces of Absolute Black granite were used for the base of the building, while the same material, in 6- x 6-inch pieces, was used around the teller area of the bank.

Additionally, the base of the building is comprised of Absolute Black granite, which was also distributed by Dal-Tile Corp. The bottom 2 feet of the facade features 18- x 18-inch pieces of granite, while smaller 6- x 6-inch pieces were used around the automated teller area of the bank.

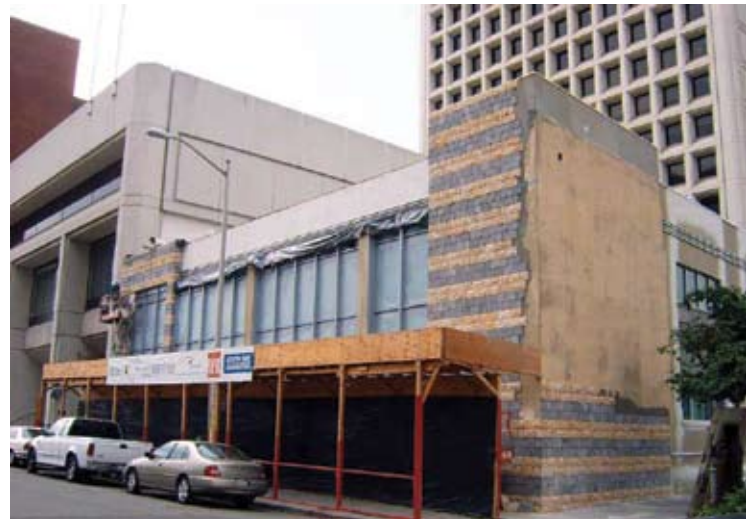
According to Design Principal Michael Perkocha, AIA of RPR Architects, the biggest challenge was in applying the stone veneer to an existing building with multiple substrates.

According to the architect, the biggest challenge was in applying the stone veneer to an existing building with multiple substrates. "In some areas, we had to apply the veneer to a brick wall, and in other areas to a steel framing," he said. "Another challenge was that with the ashlar pattern and random sizes of the stone, the material had to be laid up

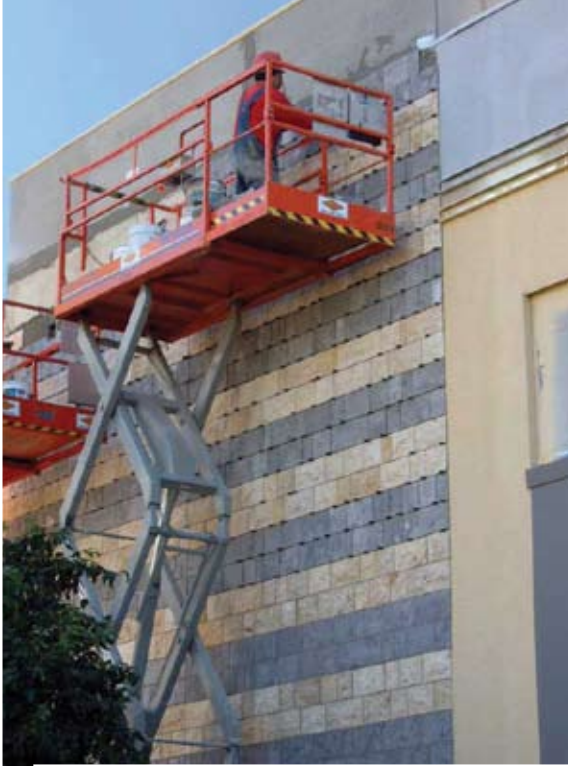
Due to the ashlar pattern and random sizes of the stone, the material had to be laid up using some artistic interpretation on the part of the masons, according to the architect. "The stone had to be carefully aligned so it maintained the random appearance of ashlar masonry," he added.

using some artistic interpretation on the part of the masons. The stone had to be carefully aligned so it maintained the random appearance of ashlar masonry.

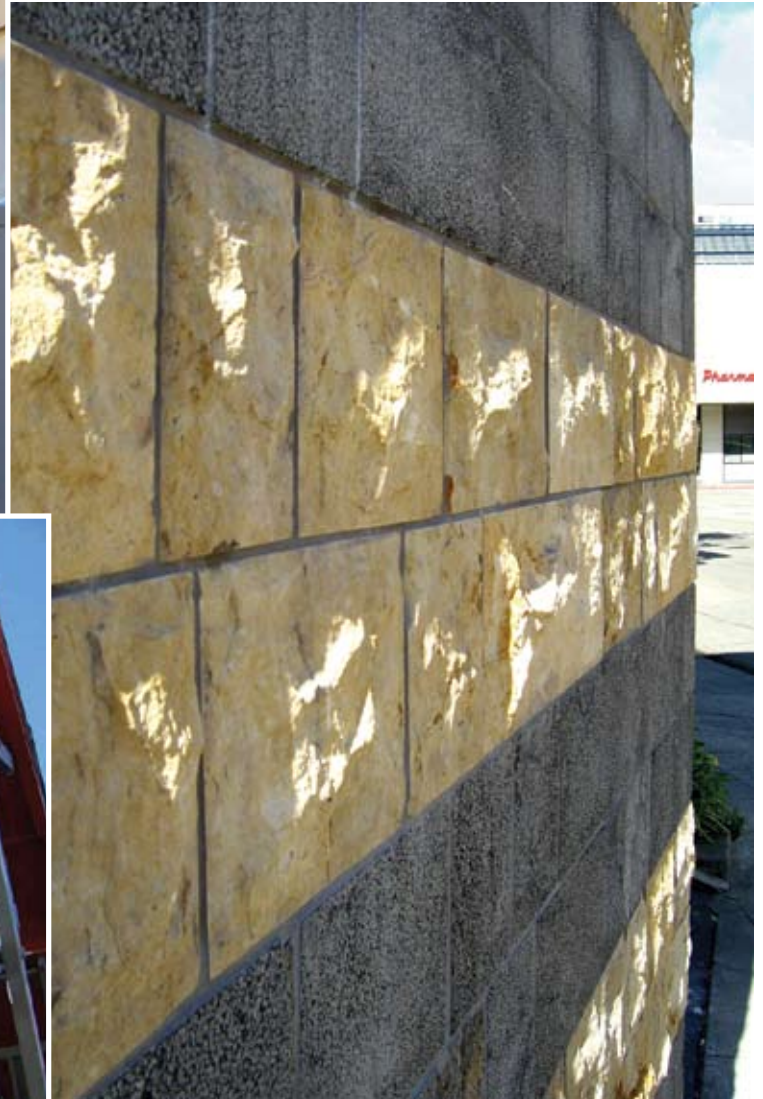
The exterior limestone features a combination of bushhammered and split-faced finishes.

RPR Architects considered a number of stone finishes before ultimately selecting a combination of bushhammered and split-faced. “We wanted something very eye-catching in terms of colors,” said the architect. “The bushhammered and split-faced finishes are appealing for aesthetic reasons and are also less attractive to graffiti due to their very coarse textures. Stone was the right choice for the bank, as it made it seem solid and substantial.

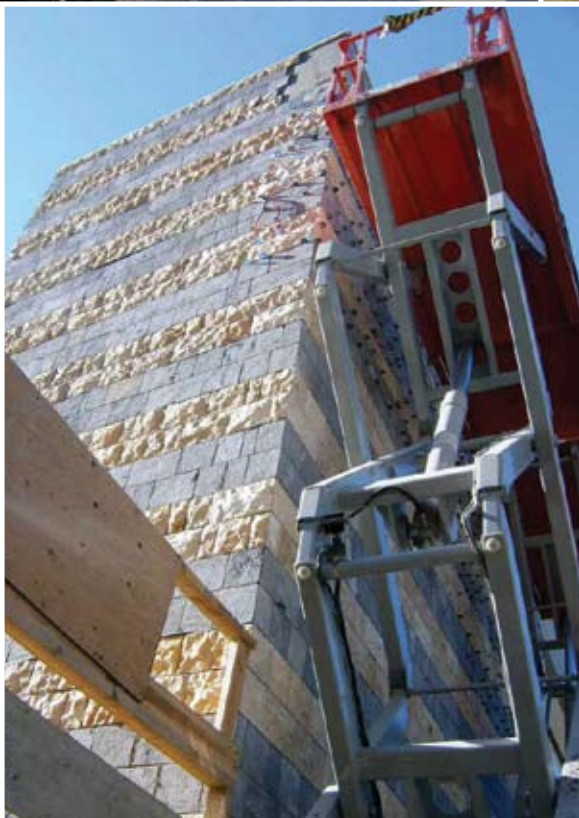
"The stone was sealed with ProSoCo Limestone and Marble Protector to sharpen the contrast and enhanced the color and veining of the natural stone veneer while aiding with maintaining the crispness of the design," the architect said.

the split-faced material tends to be thicker at the edges of the building, according to Perkocha. "The stone was sealed with ProSoCo Limestone and Marble Protector to sharpen the contrast and enhance the color and veining of the natural stone veneer, while aiding with maintaining the crispness of the design," he said. Perkocha also added that the exposed corners of the stone were all mitered,

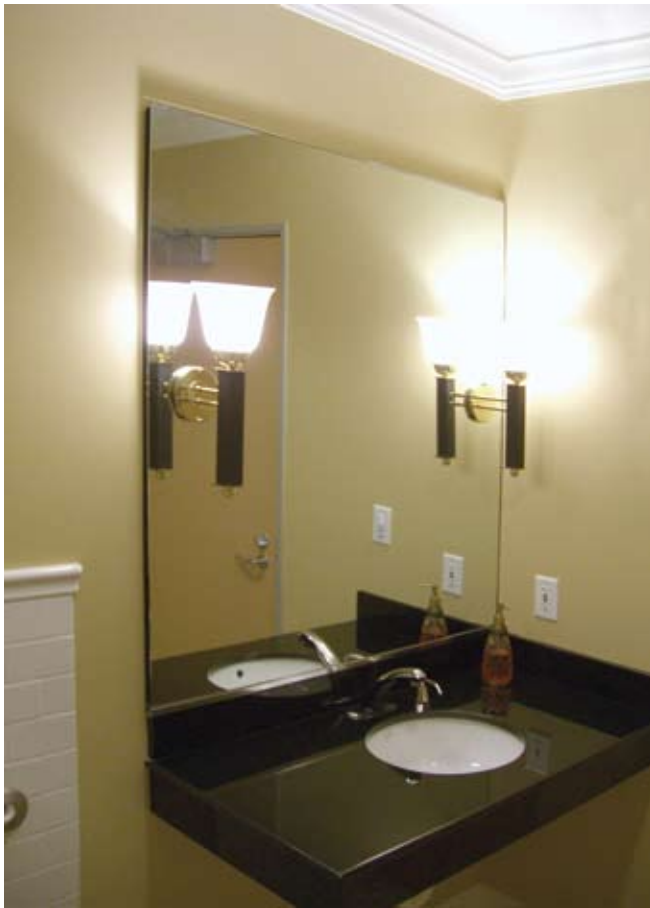
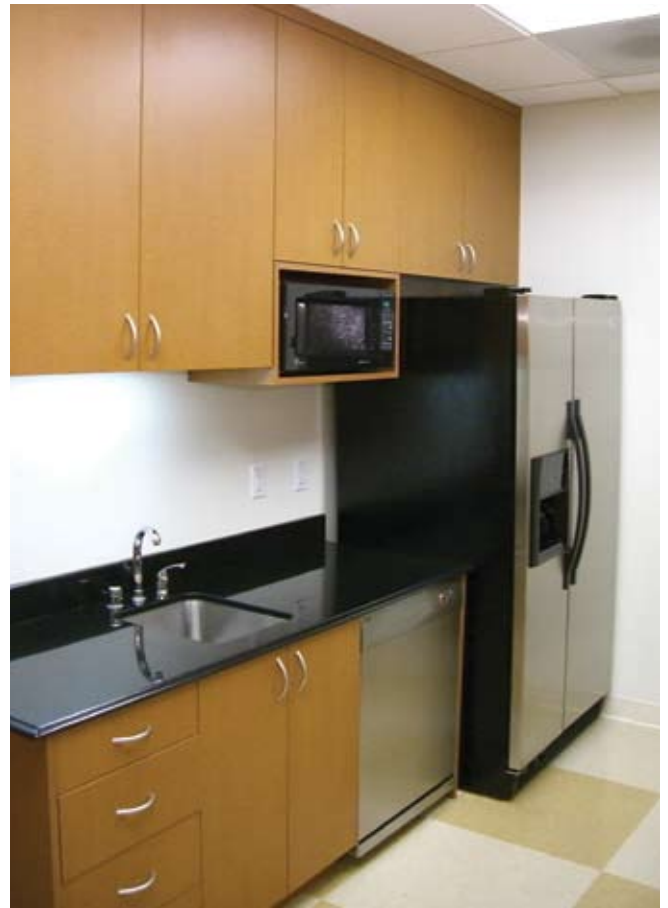
Absolute Black granite was also carried inside the building, as slabs were used for bathroom and kitchen countertops. This met the owner's request that the interiors would be "warm and inviting, with an upscale comfortable atmosphere."

Natural stone was also carried inside the building, as slabs of Absolute Black granite were used for bathroom and kitchen countertops. This met the owner's request that the interiors would be "warm and inviting, with an upscale comfortable atmosphere." "We wanted
